## Willow Creek Road 2<sup>nd</sup> Bridge Area Fish Passage Project: Phase I

### Interim Report – 30% Design and the Preferred Alternative

October 2008

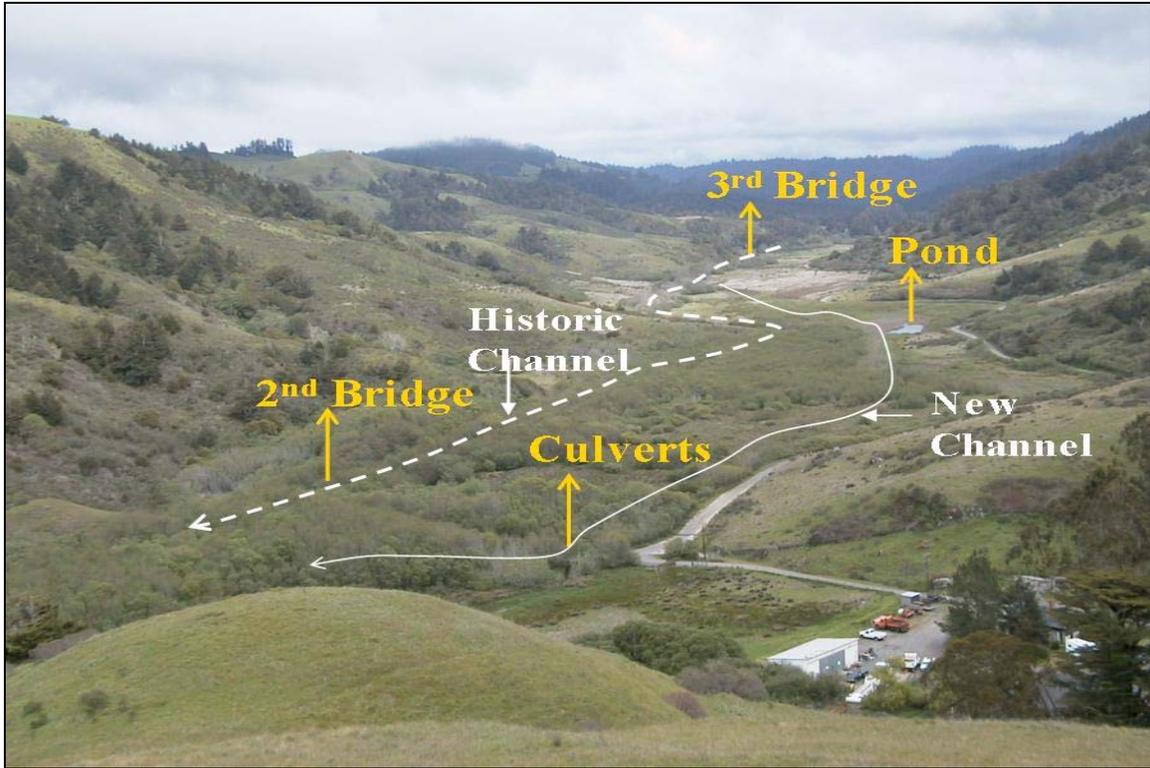
*Figure 1. Lower Willow Creek with features shown that relate to this project (photo looking up the watershed).*

Severe channel aggradation in lower Willow Creek in the vicinity of 2<sup>nd</sup> Bridge up to 3<sup>rd</sup> Bridge has led to abandonment of the historic channel on the east side of the valley. The flow is now concentrated on the west side of the valley where elevations are lowest (Figure 1). The roadway across the valley floor and floodplain at the second bridge crossing acts as a low-head dam, trapping streamflow and sediment and restricting fish passage upstream and downstream during spring and winter base-flow conditions. The 24-inch culverts at the west end of the valley crossing are often blocked with debris during annual high flows. The streamflow slows and spreads across the floodplain, overtopping the roadway during most high flows (Figures 2 and 3). This condition does not provide a clear path for upstream salmonid migration. With a lack of channel continuity in this reach, upstream migration by adults and downstream migration by juveniles is severely restricted.

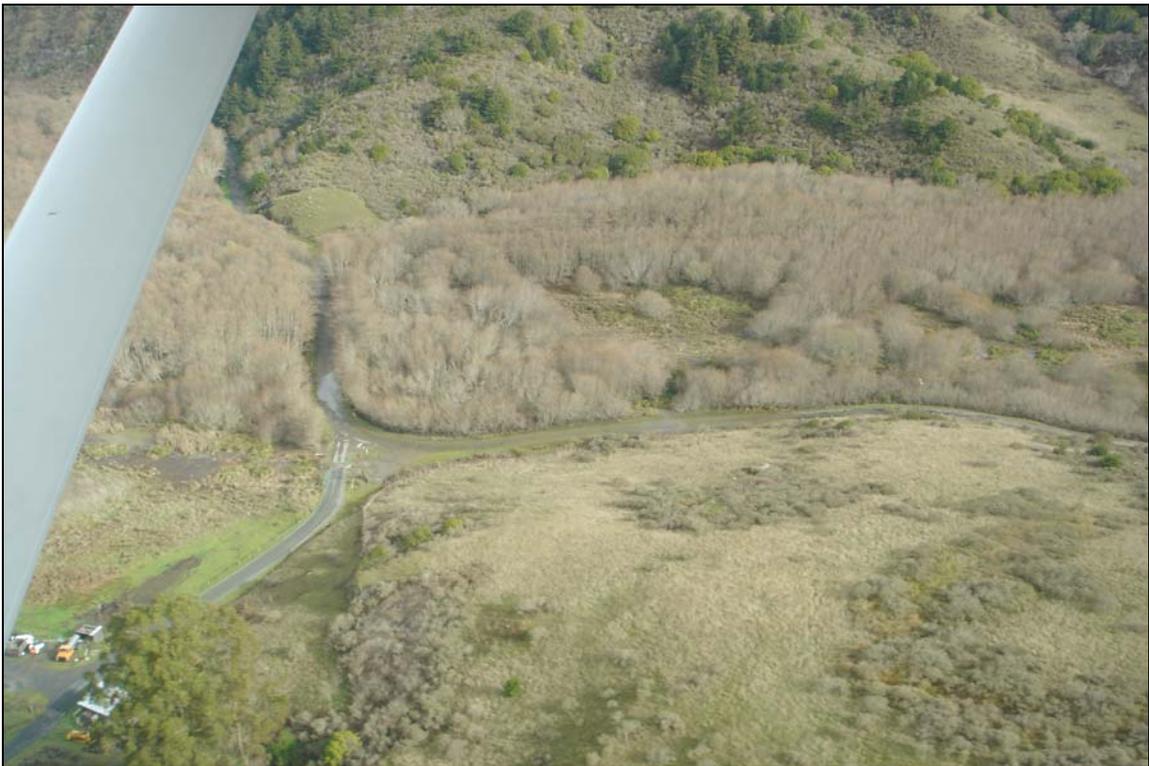
*Figure 2. Aerial view of the second bridge crossing after high flows on January 28, 2008. Note ponded water at culvert locations and southern approach.*

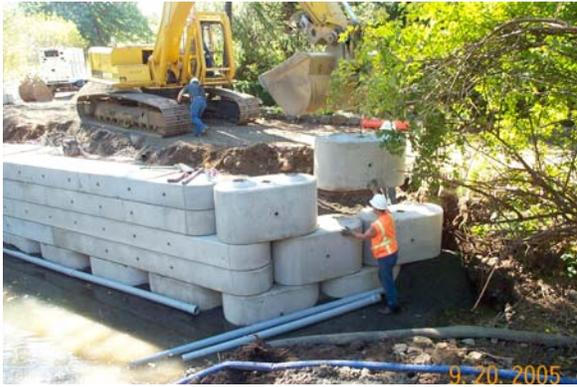
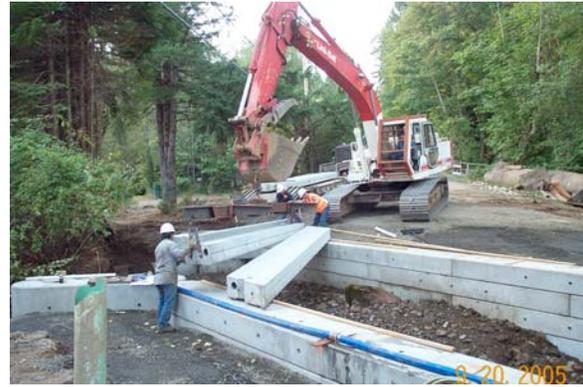
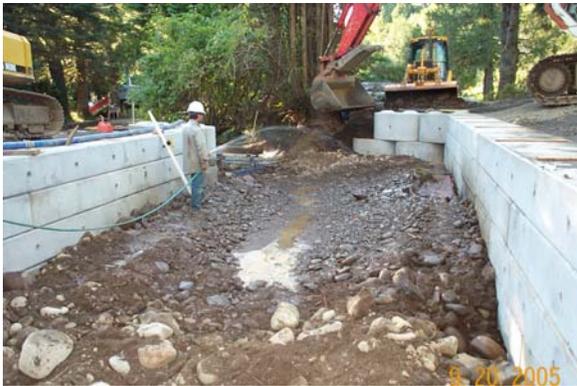
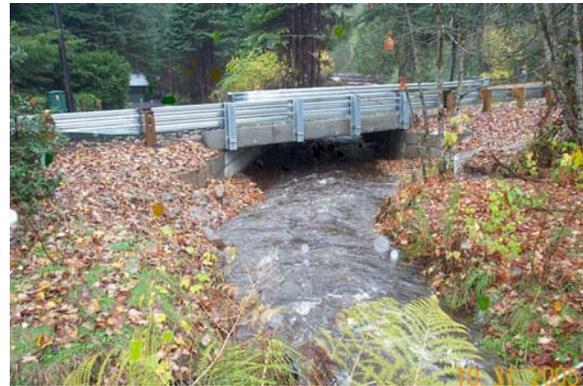
Photos courtesy of Pacific Bridge, 2008

Pacific Bridge out of Sandy, Oregon designs and constructs precast bridges for culvert replacement projects (see photos below for examples). A standard maximum free span width of this type of bridge is 43 feet with 2.5-foot abutments on either side.

Preliminary design details for the 90% design (construction bid ready) for a bridge of the type shown above, include:

- A bridge opening width of 43 feet,
- A bridge deck width of at least existing pavement width (20 feet),
- A bridge deck at an elevation of 20 feet NGVD,
- The bridge abutments supported by driven pipe piles,
- The bridge approaches graded to meet existing bridge elevation on the eastern approach and the 18-foot road contour on the western approach, and
- The channel thalweg at 12.5 feet.
