# **Russian River Estuary Management Project**

## **Marine Mammal Protection Act Incidental Harassment Authorization (No. 14426)**

### **Report of Activities and Monitoring Results – April 1 to December 31, 2010**

Prepared by  
Sonoma County Water Agency  
404 Aviation Blvd.  
Santa Rosa, CA 95403

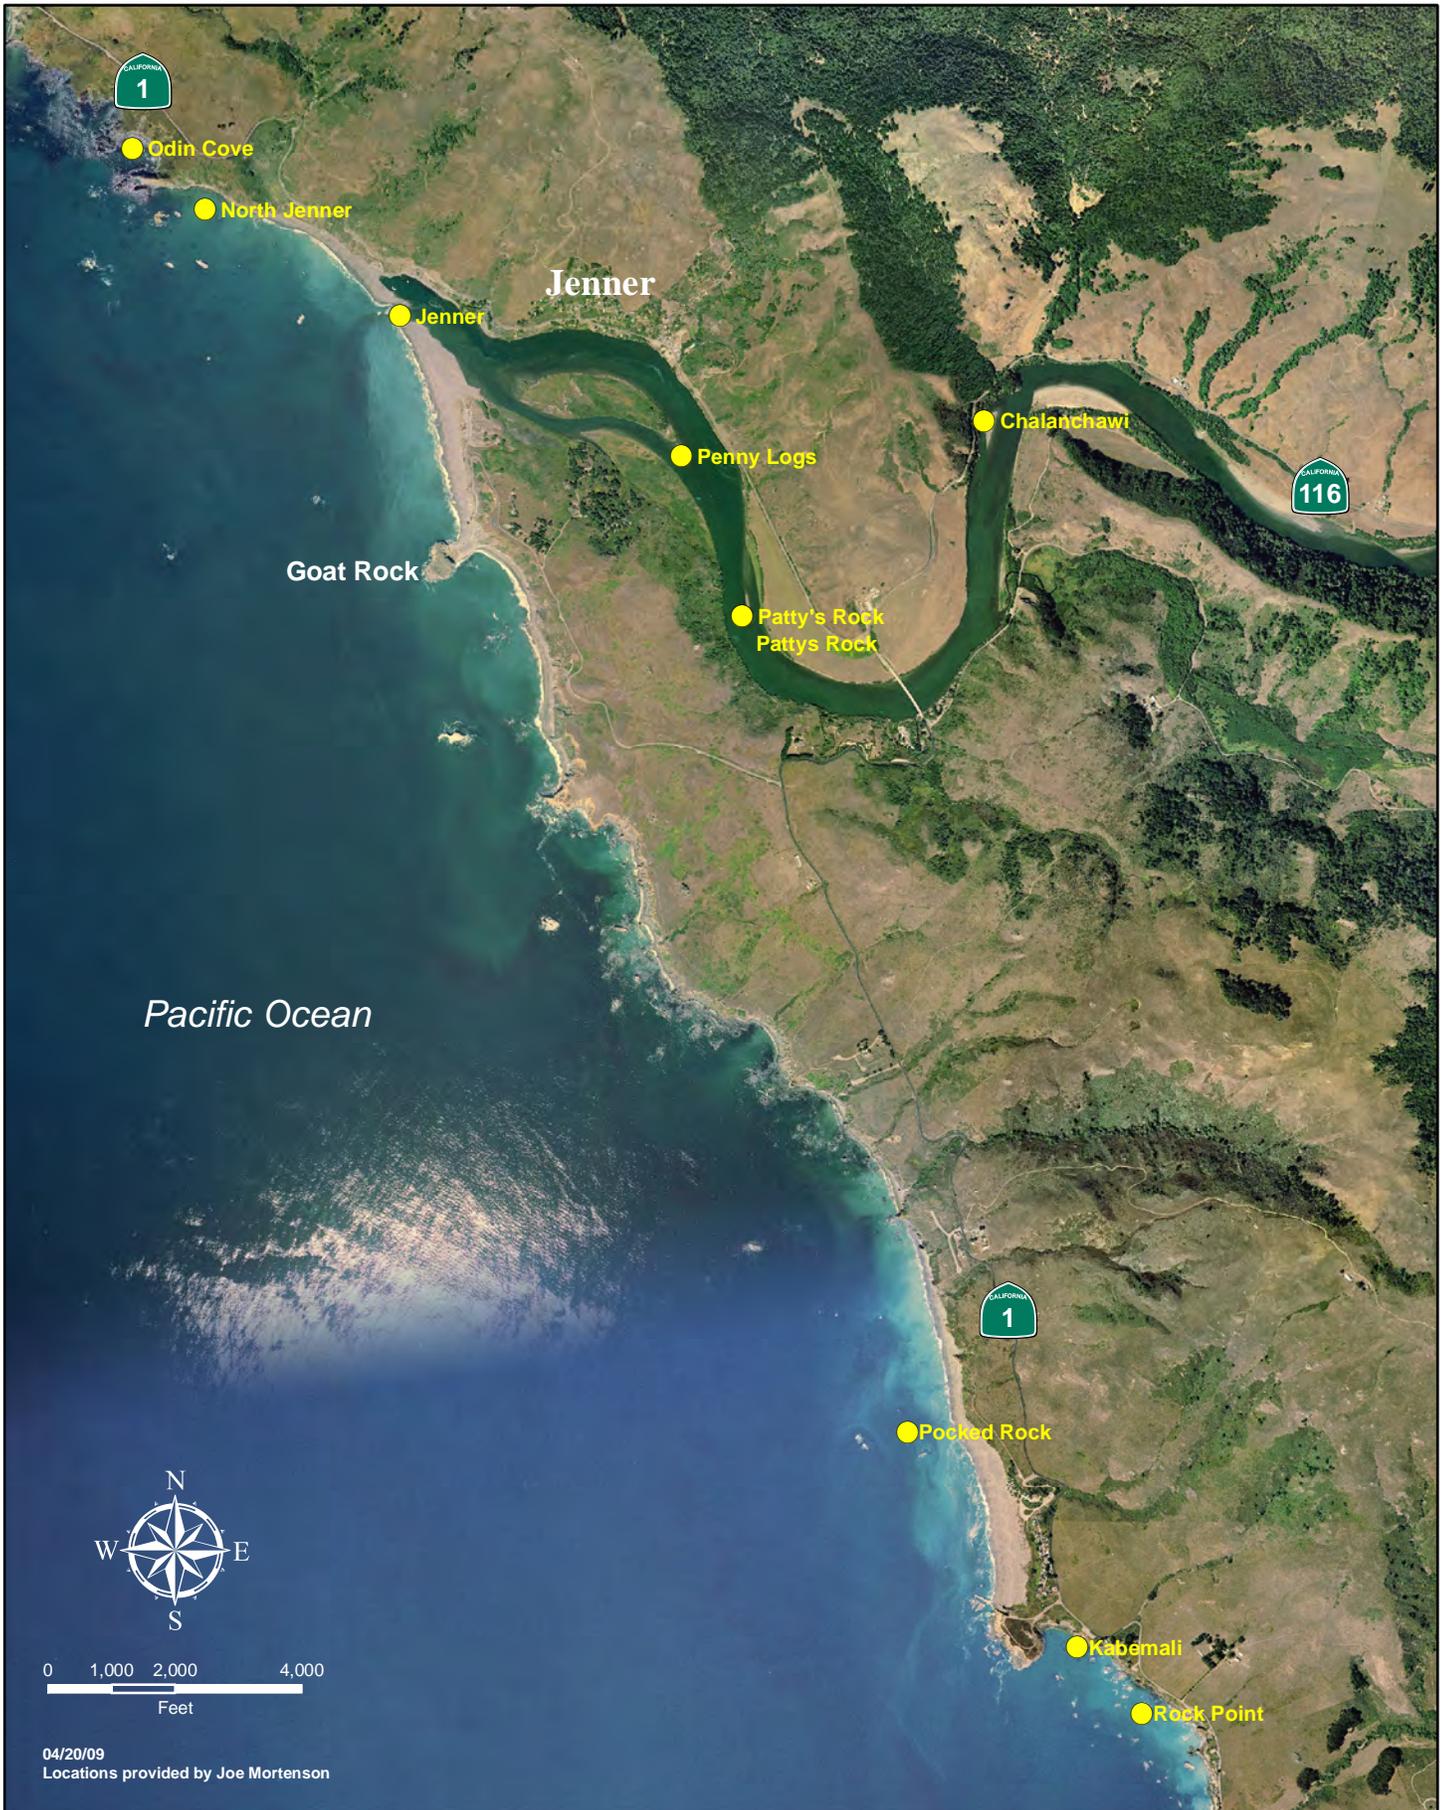
Figure 2

# Pinniped Haulouts at the Russian River Estuary and Surrounds

Harbor seals (*Phoca vitulina richardii*) regularly haul out at the mouth of the Russian River (Jenner haulout) (Figure 2). California sea lions (*Zalophus californianus*) and northern elephant seals (*Mirounga angustirostris*) are occasionally observed at the haulout. There are also several known river haulouts at logs and rock piles in the Russian River estuary (Figure 2). The Water Agency applied for an IHA under the MMPA for activities associated with Russian River estuary management activities, including:

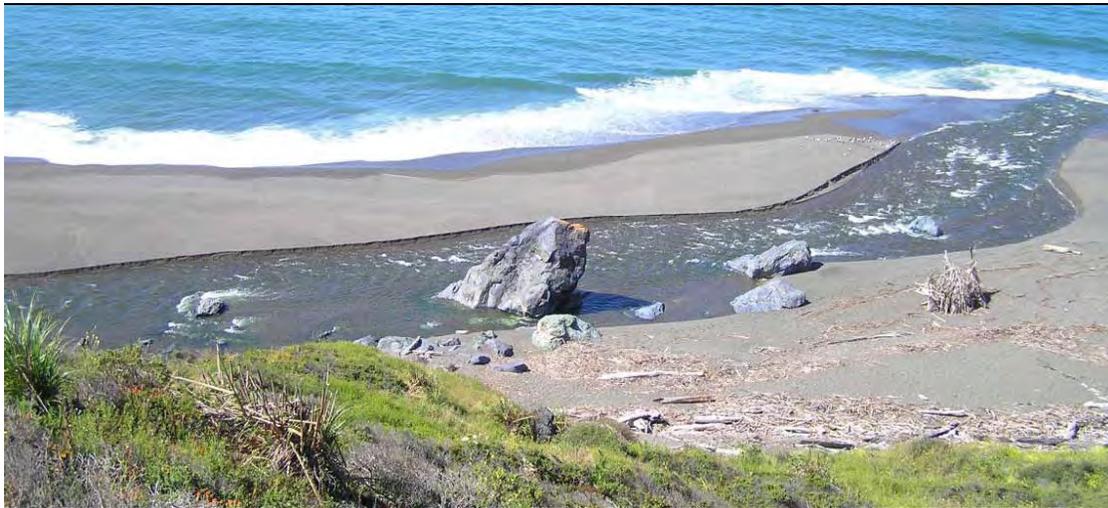
July 1, 2010 Natural Open Channel. Photo from Highway 1 Overlook.

**Figure 3.** Russian River Estuary: Natural outlet channel closed and created outlet channel conditions, July 2010

The July 8, 2010, beach management event was the only lagoon management event in 2010. The barrier beach formed, closing the mouth of the Russian River, on July 4, 2010. Prior to the closure, the river channel had been flowing to the northwest in an orientation similar to the target orientation for the lagoon outlet channel (Figure 3). Prior to the closure, harbor seals were observed at the Jenner haulout. The most recent Baseline census was on June 21, 2010, when a mean of 184 harbor seals was observed (Table 3).

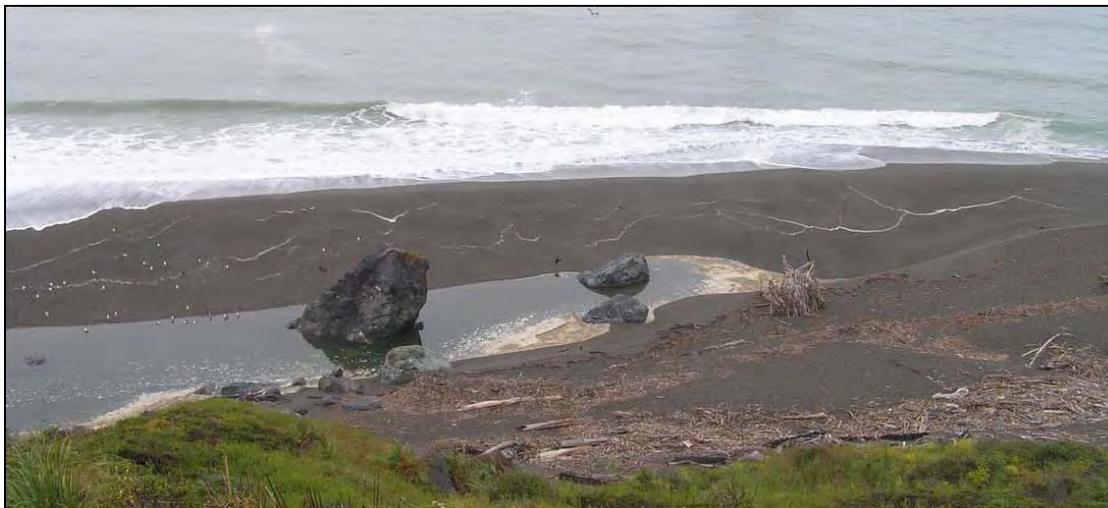
July 7, 2010 Channel Closed by Tidal Action. Photo from Highway 1 Overlook.

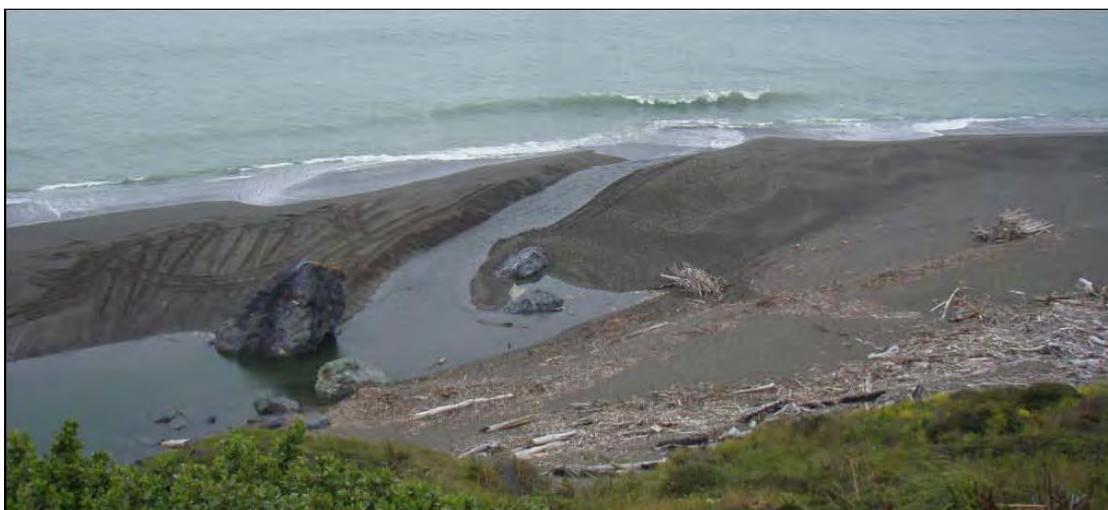
July 8, 2010 Created Outlet Channel. Photo from Highway 1 Overlook.

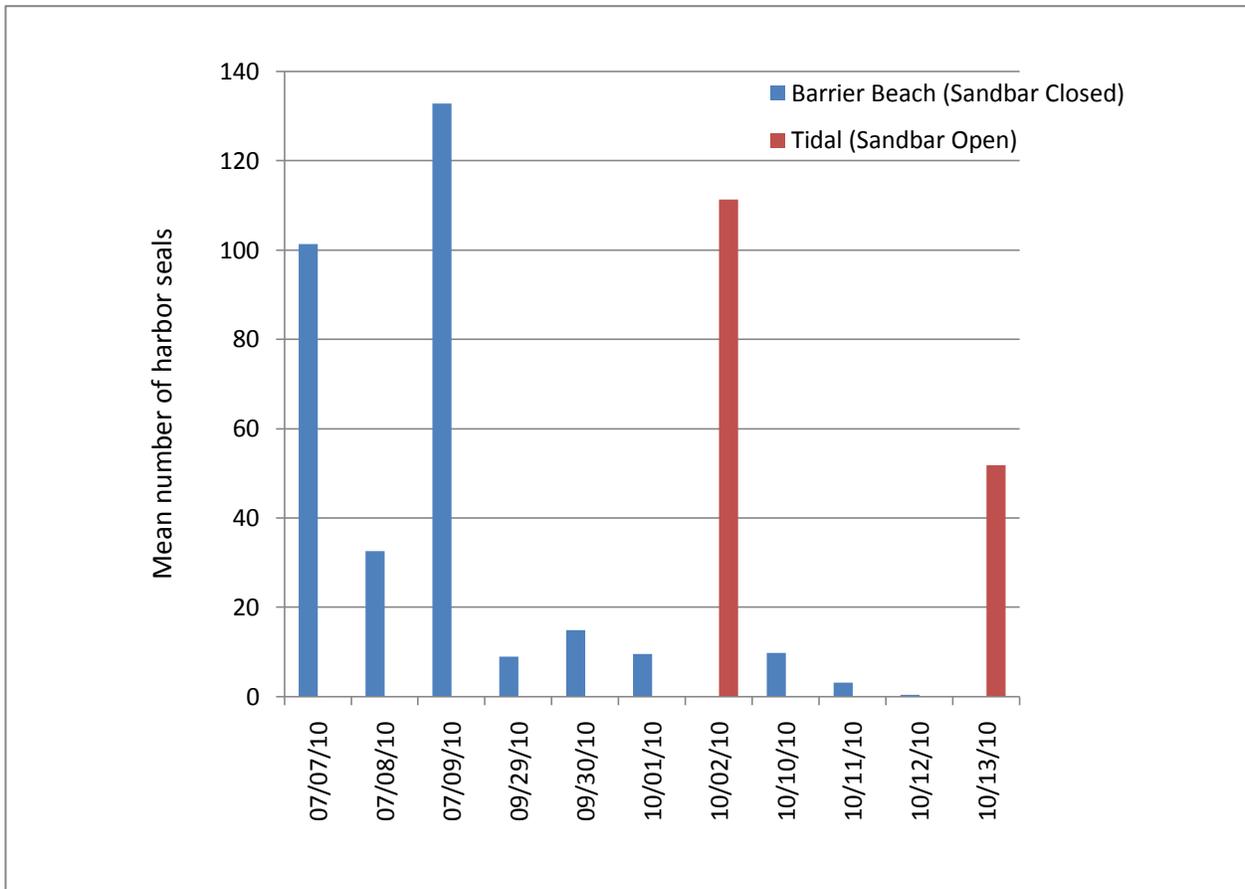
**Figure 4.** Mean number of harbor seals observed at the Jenner haulout (Goat Rock State Beach) during pinniped monitoring for Russian River Estuary Project water level management activities from April to December 2010.
